Home Inspection Report

123 Forth Place
Anytown, USA 12345

Prepared for: Sample

Prepared by: Caveat Emptor Home Inspectors
14 Sterling Place
Glen Rock, New Jersey 07452

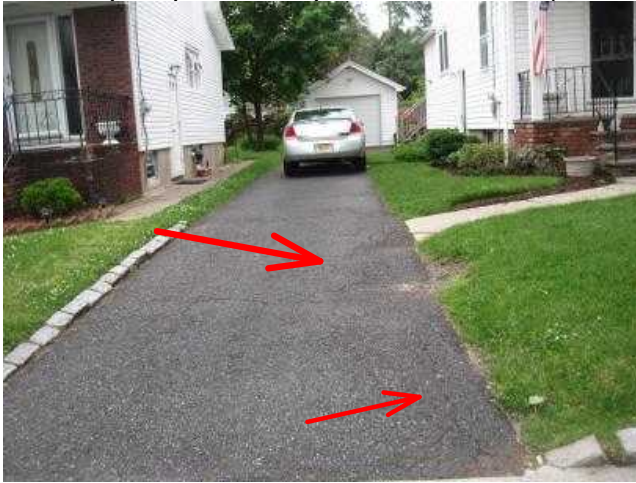
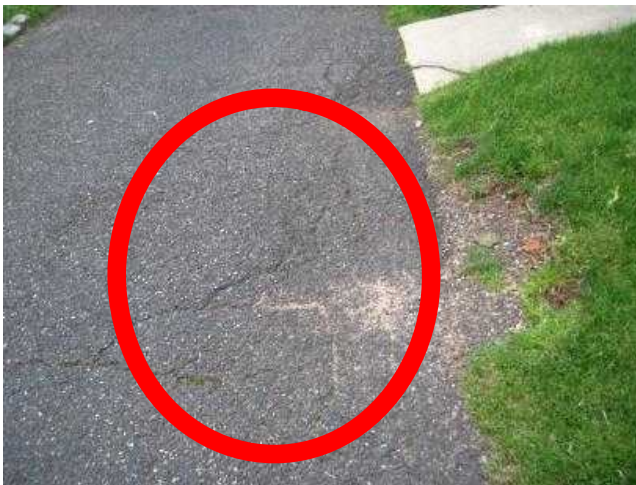
Marginal Driveway: Asphalt Heavy cracks in surface, Uneven settling

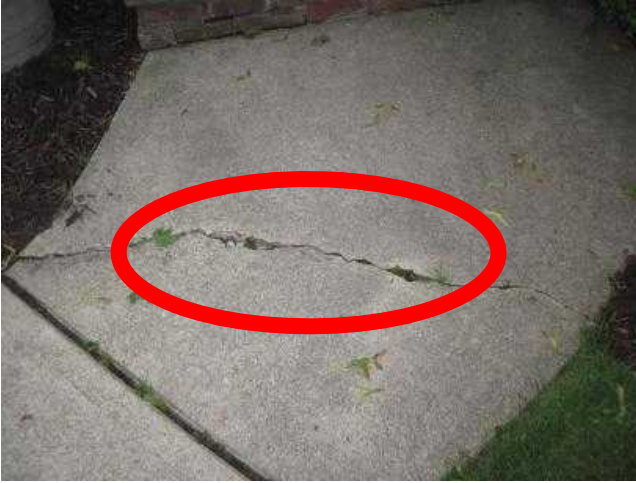
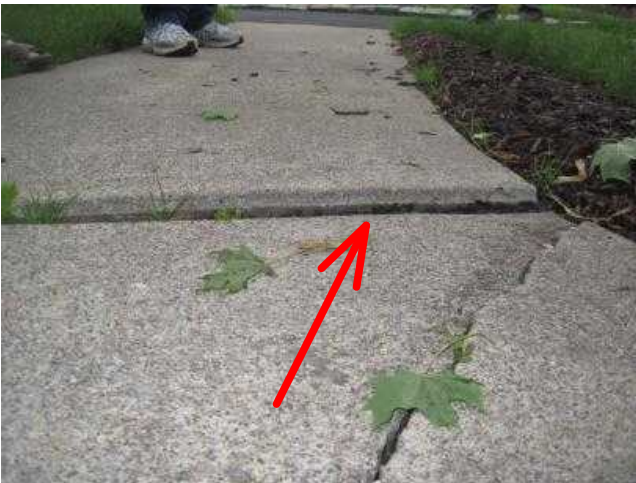
Defective Walks: Concrete Cracked, Trip hazard

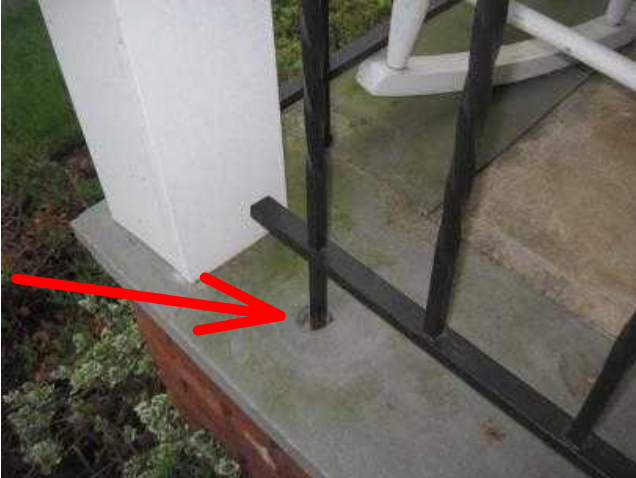
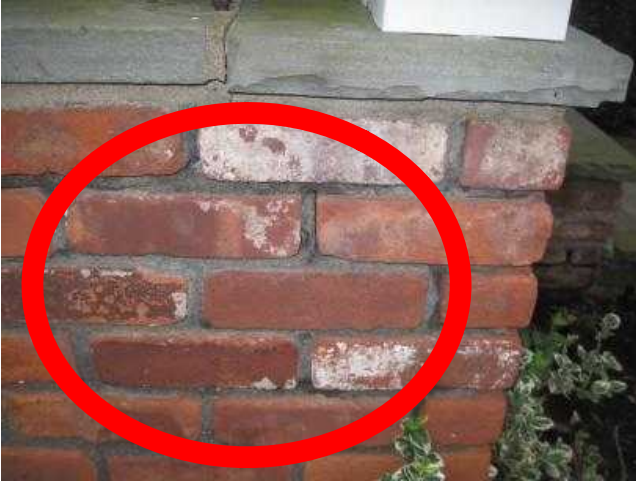
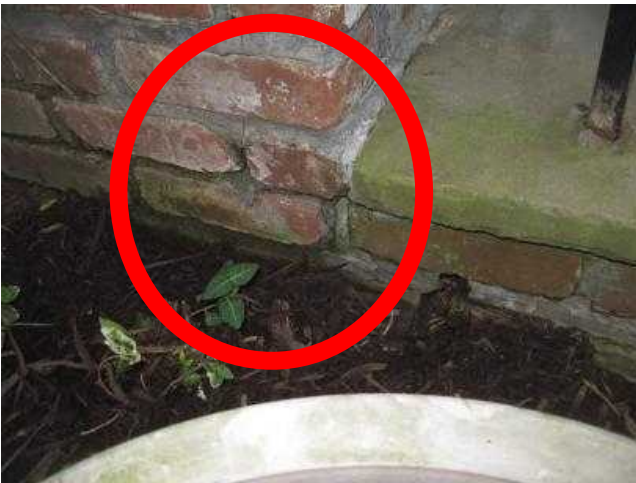
Marginal Steps/Stoops: Brick Railings loose, safety hazard., Bricks need pointing.

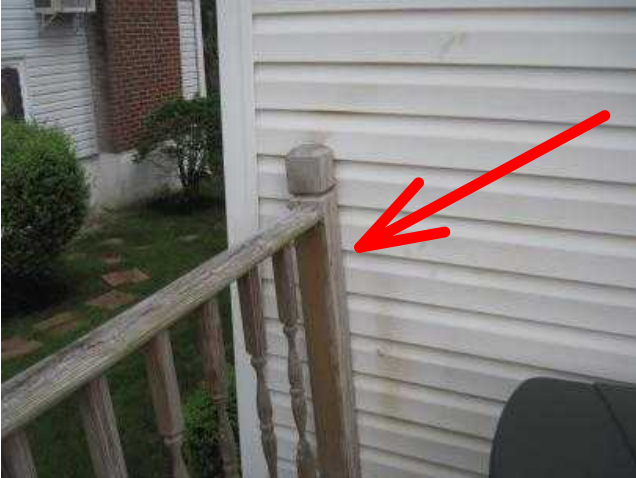
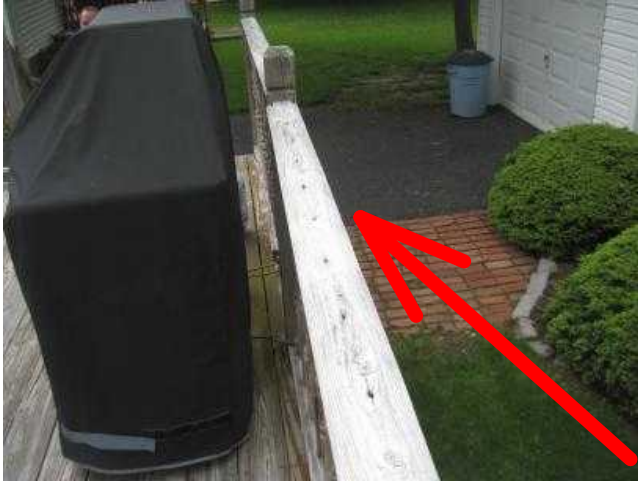
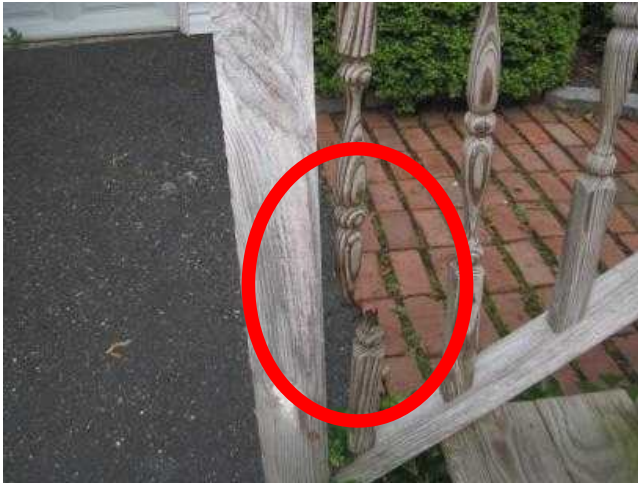
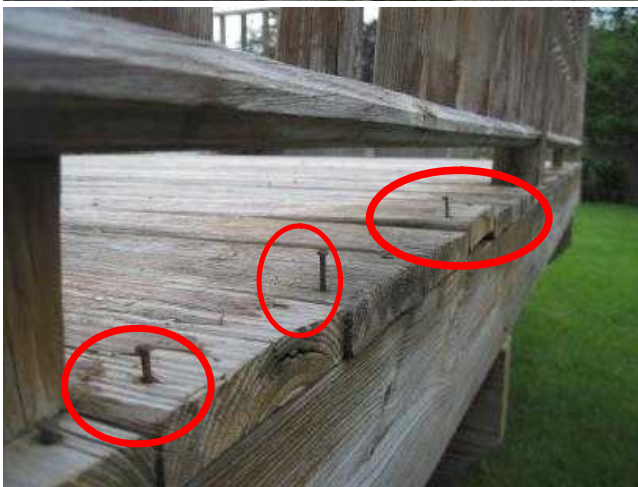
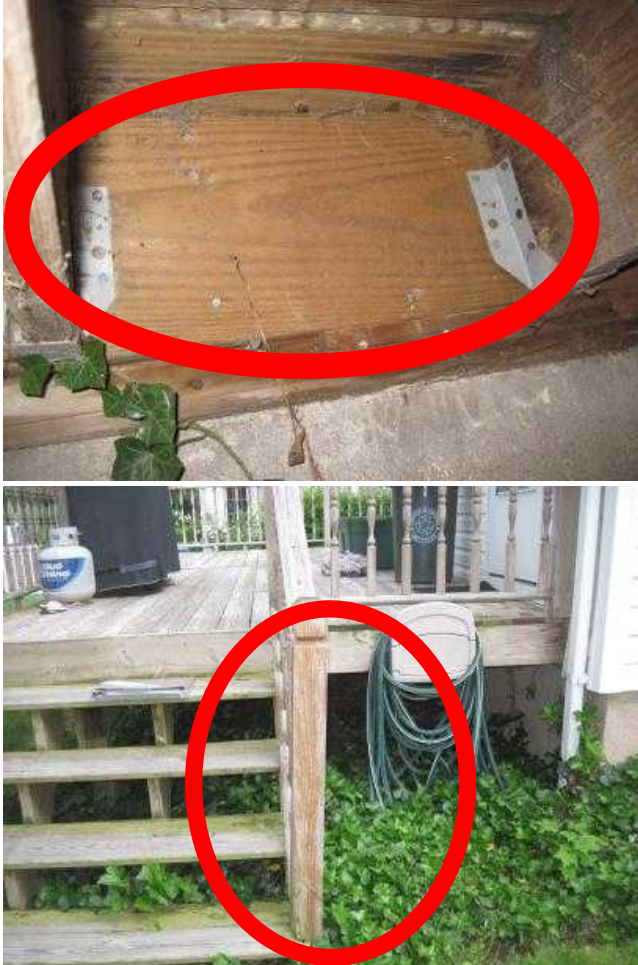
Deck: Stained wood Not lag bolted to house, Railing support loose., Baluster openings too wide

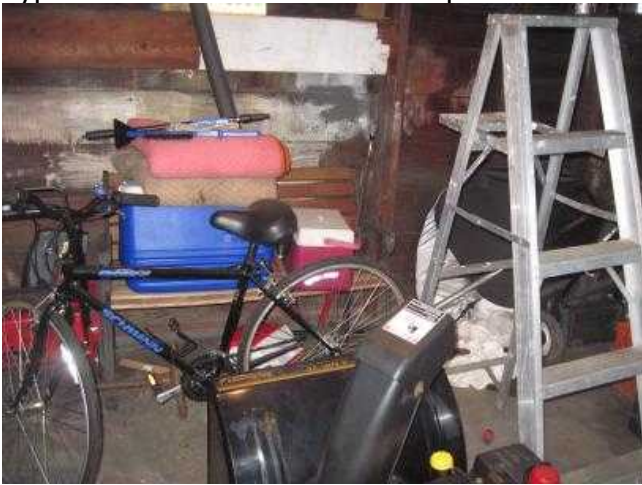
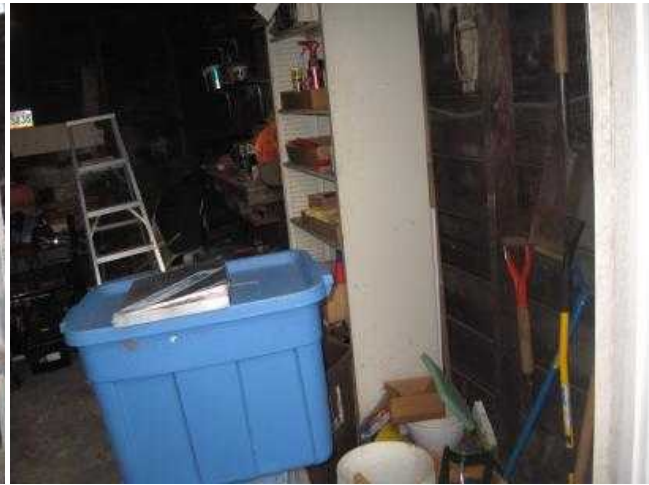
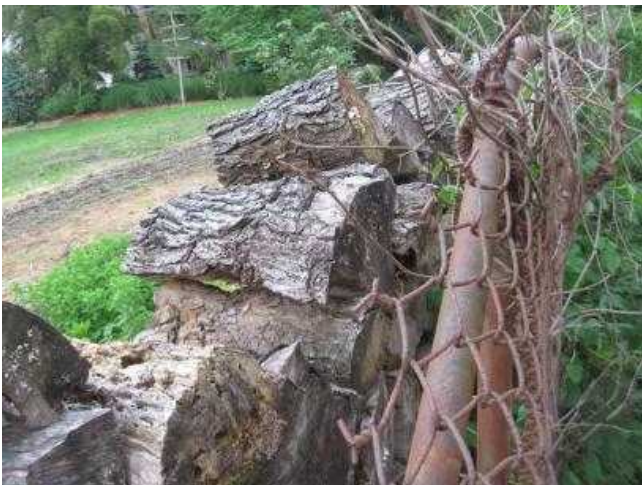
Garage Doors: Insulated aluminum
Door Operation: Manual
Exterior Surface: Vinyl siding Wood siding in contact with soil. Promotes termites.

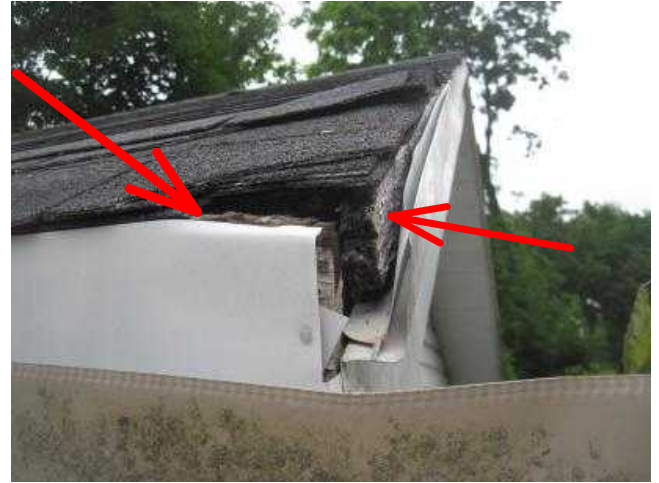
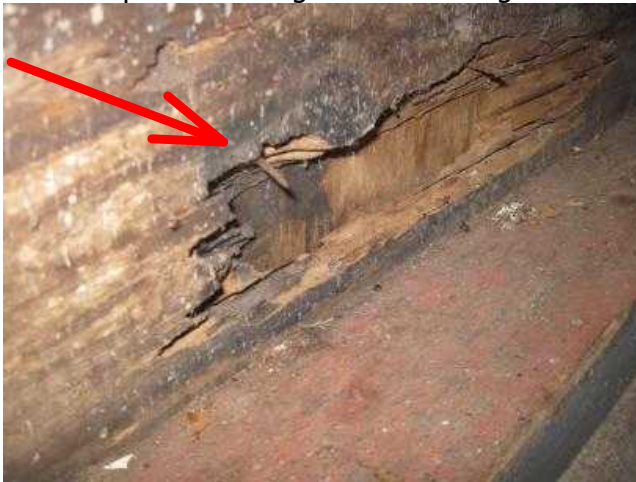
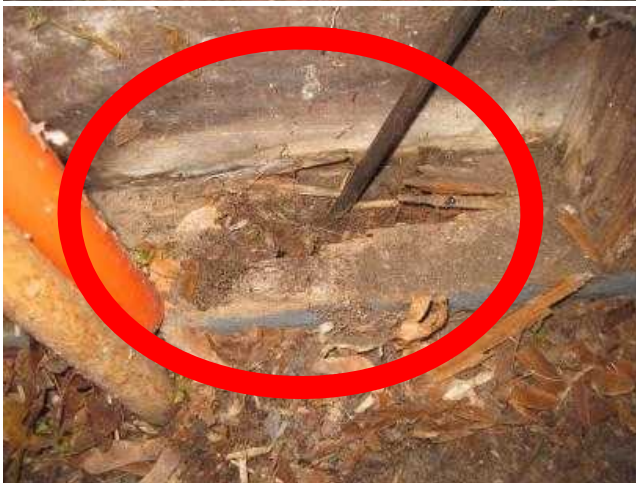
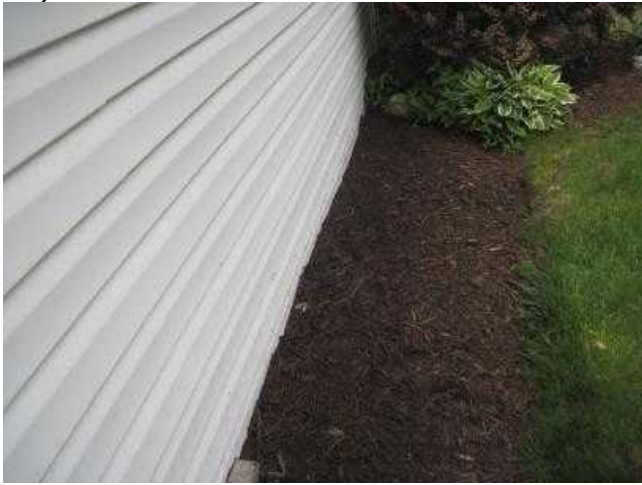
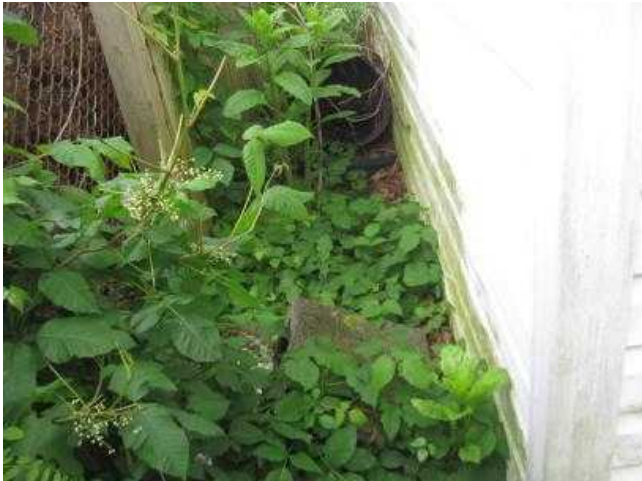
Roof Structure: 2x6 Rafter Trim boards rotted.
Ceiling: Exposed framing
Walls: Exposed framing Termite damage

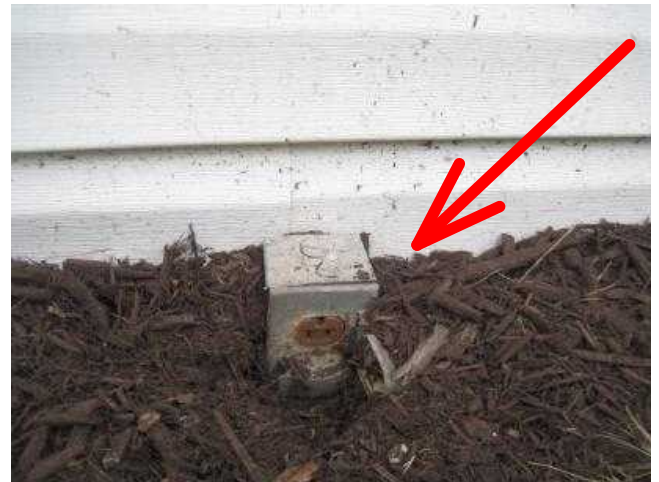
Floor/Foundation: Poured concrete Floor settled
Electrical: 110 VAC outlets and lighting circuits
Buried outlet on exterior. Fire Hazard !

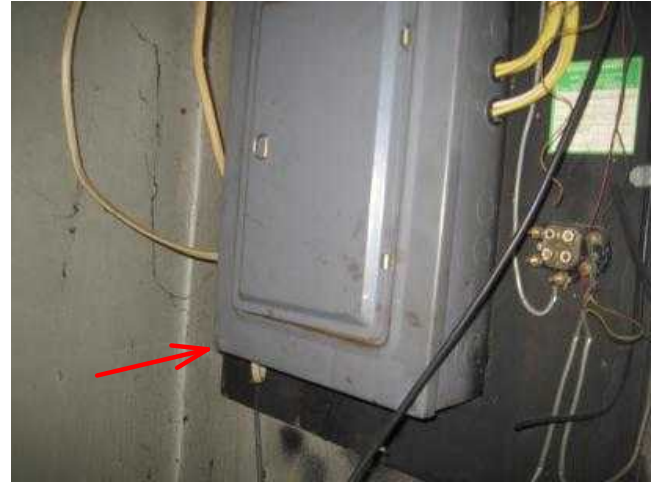
Acceptable Manufacturer: Square D Missing screws

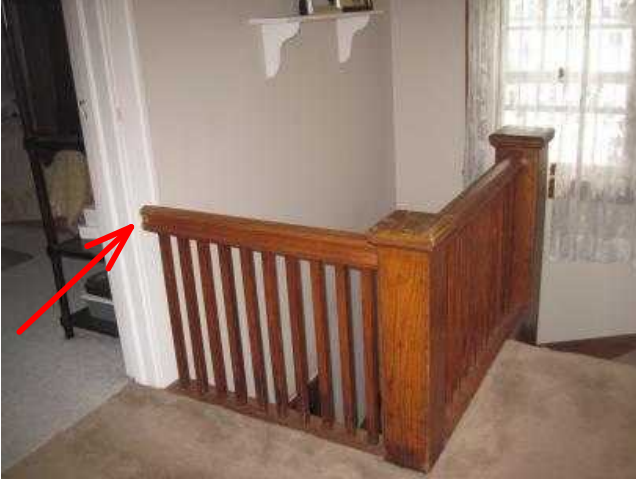
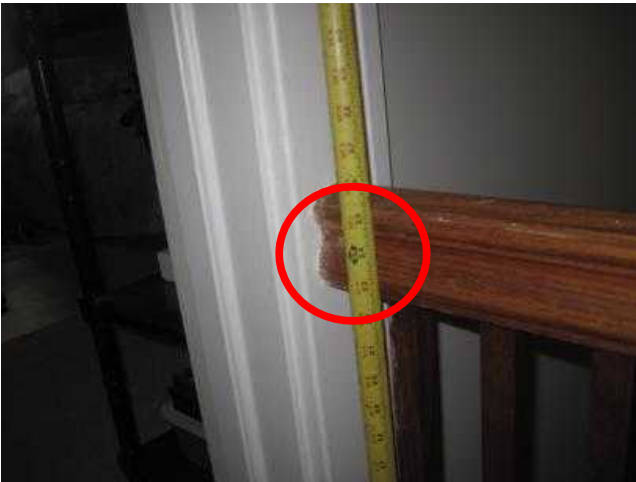
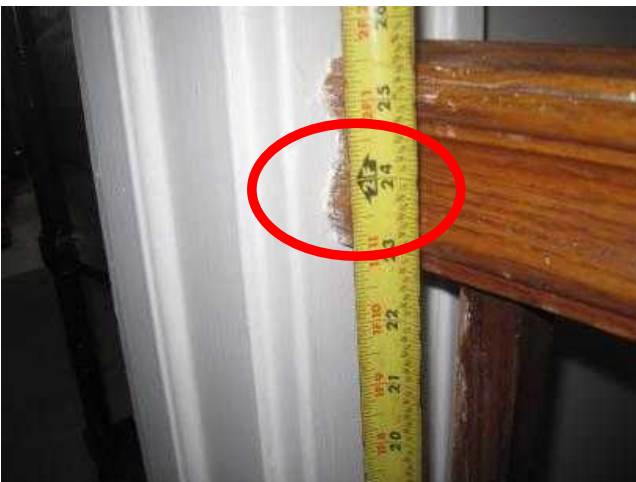
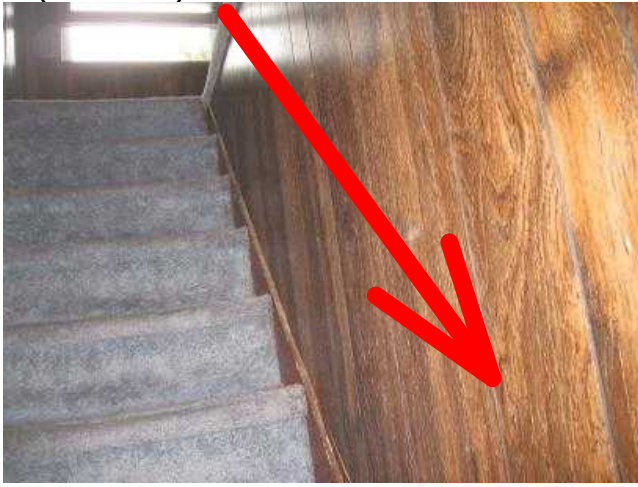
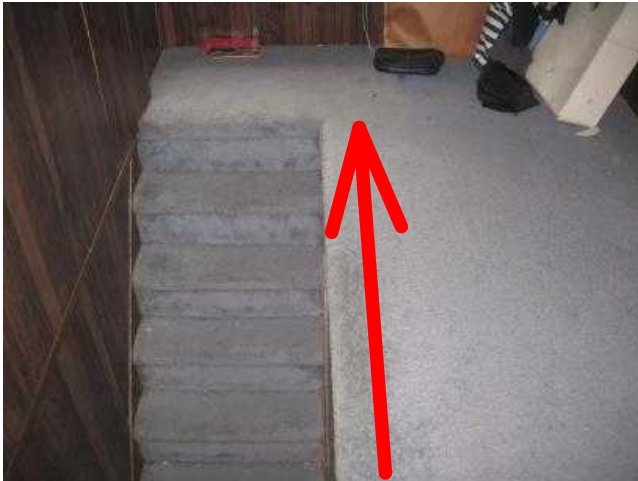
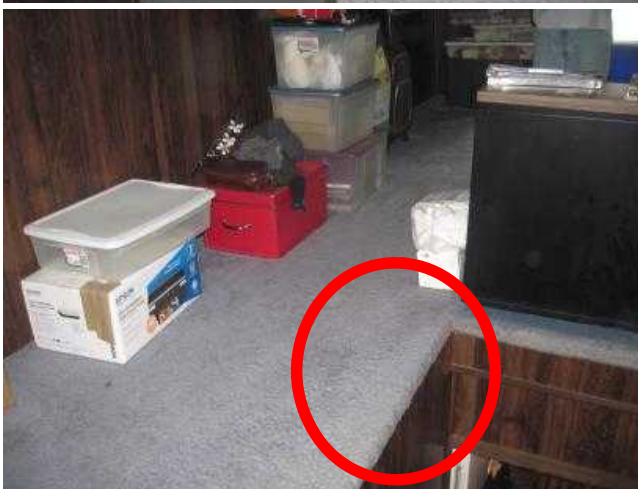
Defective Stairs/Handrails: Wood stairs with wood handrails No ballisters.(Safety), Railings to low., Handrails missing (Safety)

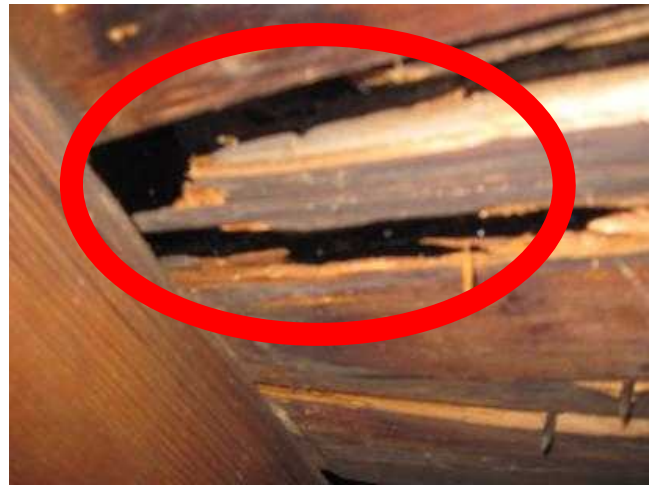
Defective Sheathing: Dimensional wood Wood rot present

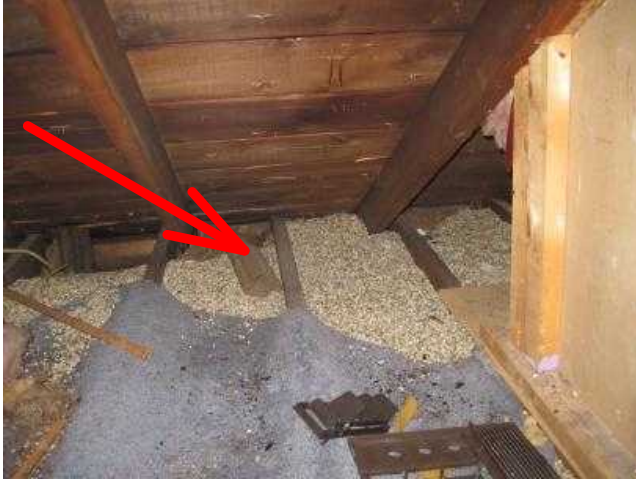
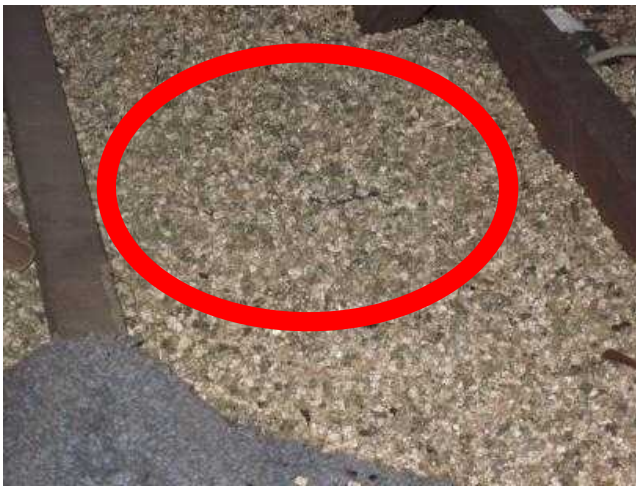
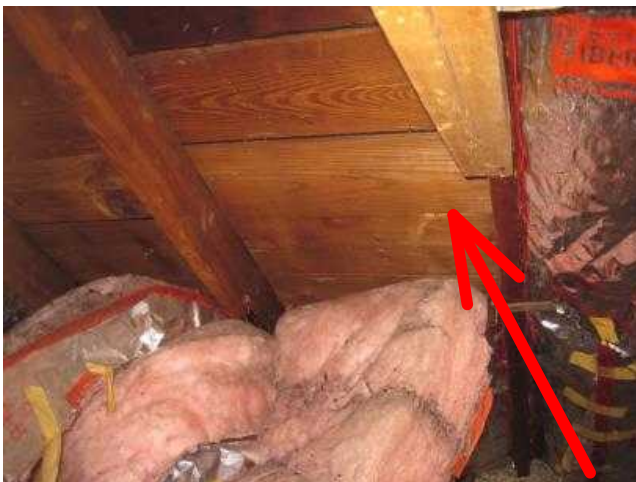
Defective Insulation: Fiberglass, Vermiculite Insulation batts have fallen out of position-properly reinstall, Vermiculite insulation present. May contain asbestos. SAFETY !

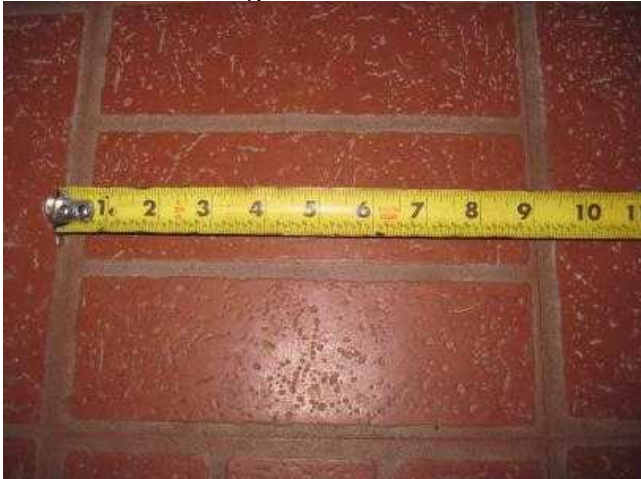
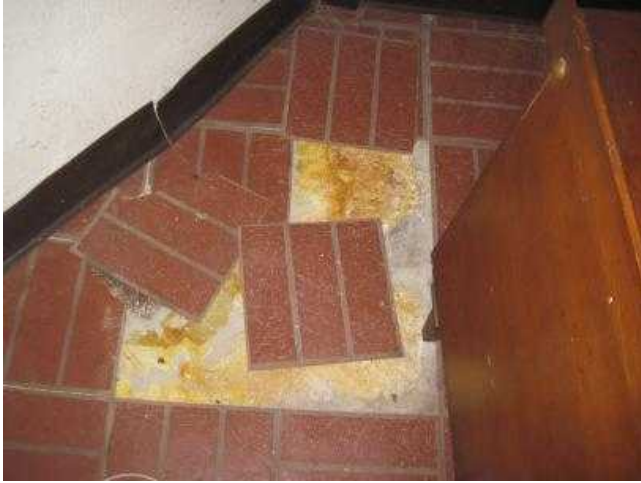
Acceptable Unable to Inspect: 80% Finished basement, Fixed ceiling
 Acceptable Ceiling: Stapled fiber ceiling tile.
 Acceptable Walls: Paneling
 Defective Floor: Tile 9x9 tile ,possible asbestos

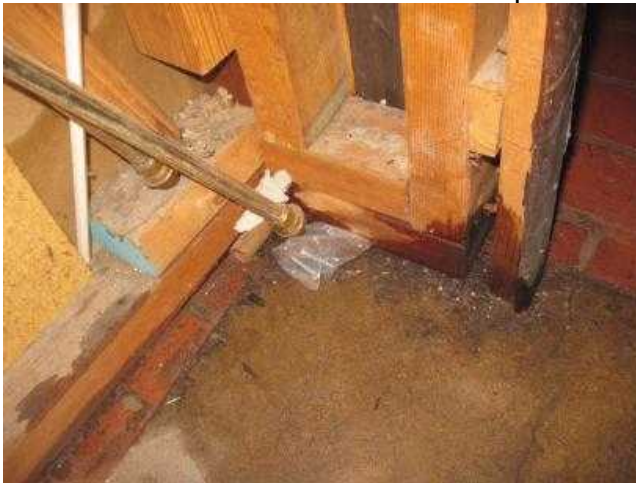
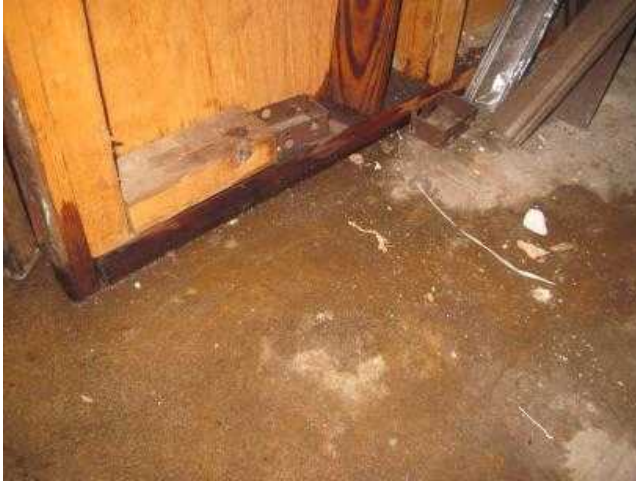
Not Present	Floor Drain:
Not Present	Doors:
Acceptable	Windows: Aluminum slider
Acceptable	Electrical: 110 VAC outlets and lighting circuits
Not Present	Smoke Detector:
Acceptable	HVAC Source: Steam boiler
Not Present	Vapor Barrier:
Not Inspected	Insulation:
Acceptable	Ventilation: Windows
Not Present	Sump Pump:
Marginal	Moisture Location: In boiler room. Dampness noted.

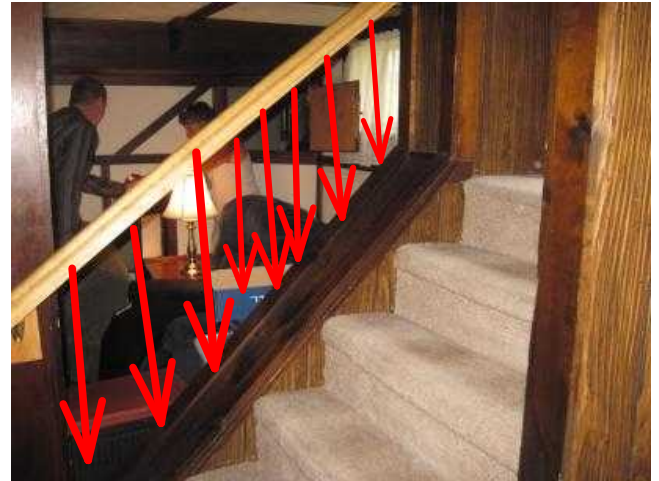
Basement Stairs/Railings: Wood stairs with wood handrails No balusters. Safety!

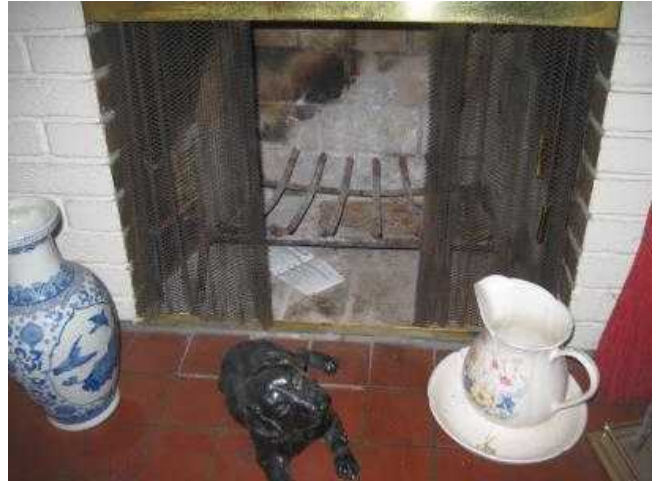
Acceptable Fireplace Construction: Brick Fireplace and components need cleaning and inspection prior to use, Have a qualified fireplace contractor inspect prior to use.

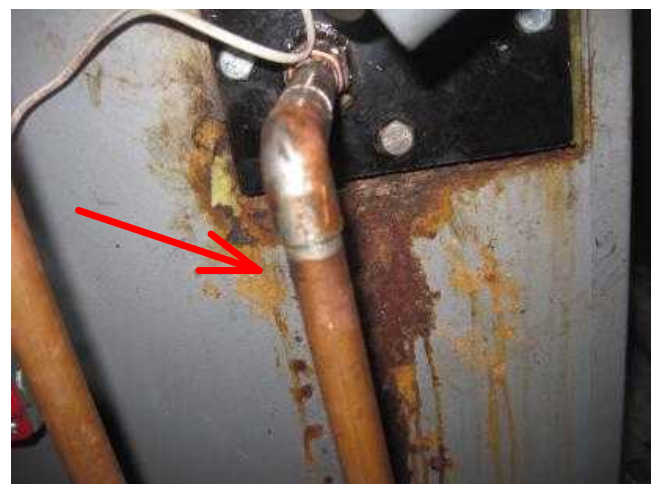
Acceptable Heating System Operation: Adequate Evidence of past water leakage at fitting.

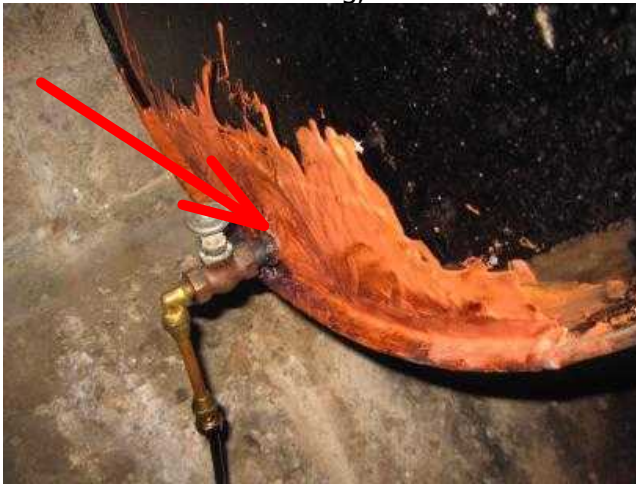
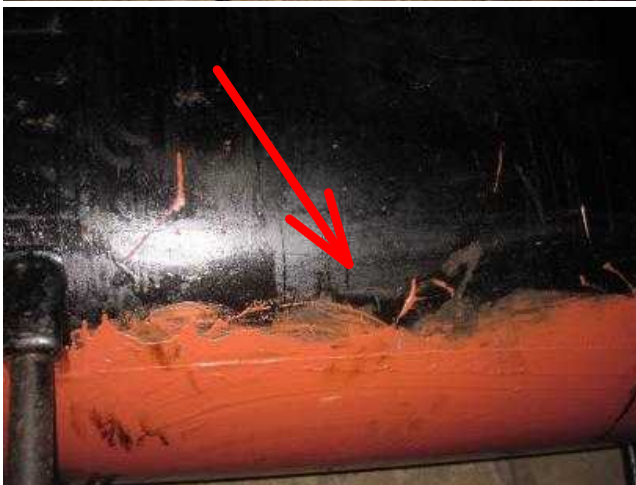
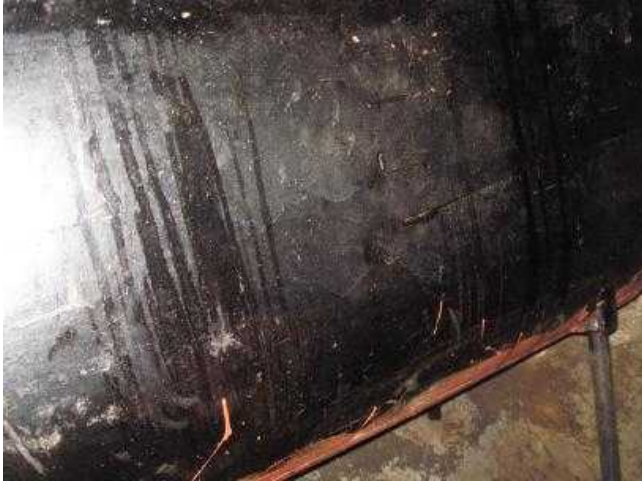
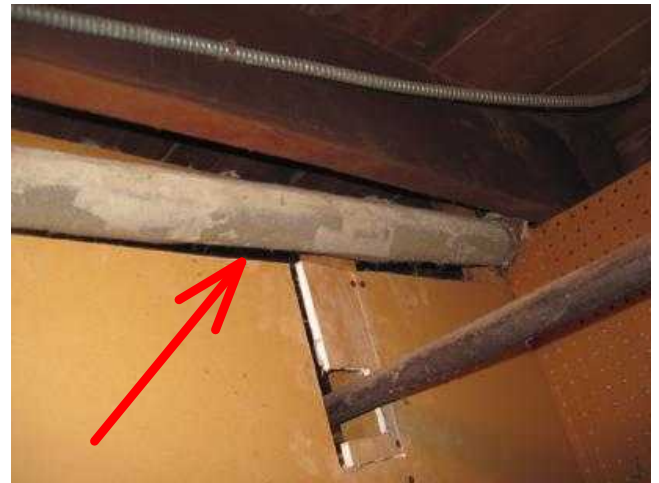
Defective Fuel Tank: Oil tank Leaking, Recommend removal by qualified contractor

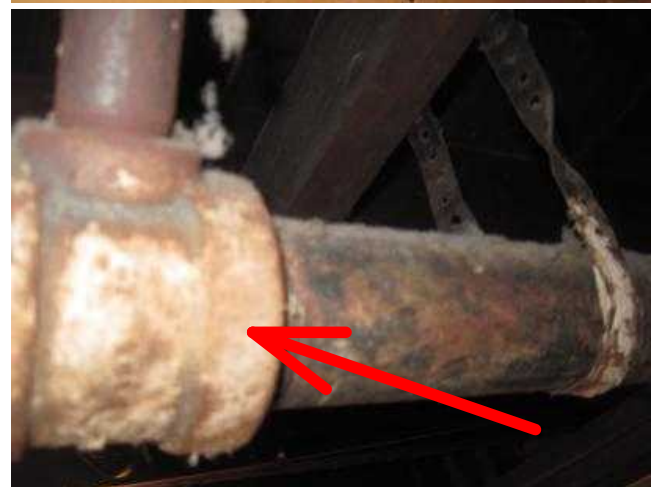
Suspected Asbestos: Yes

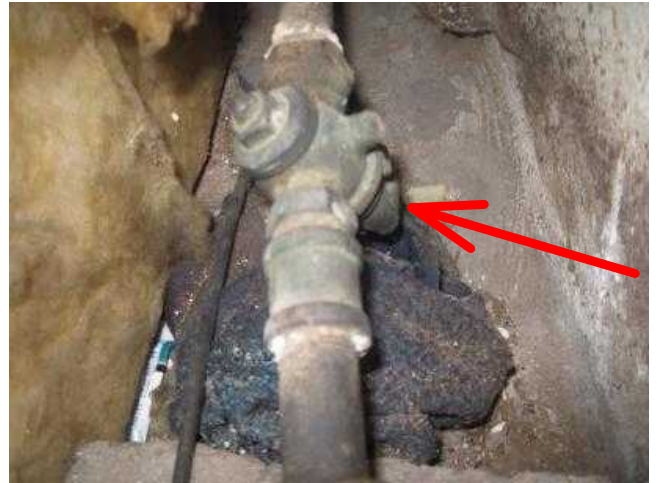
Service Line: Copper
Main Water Shutoff: Basement Broken shut off.
House side.

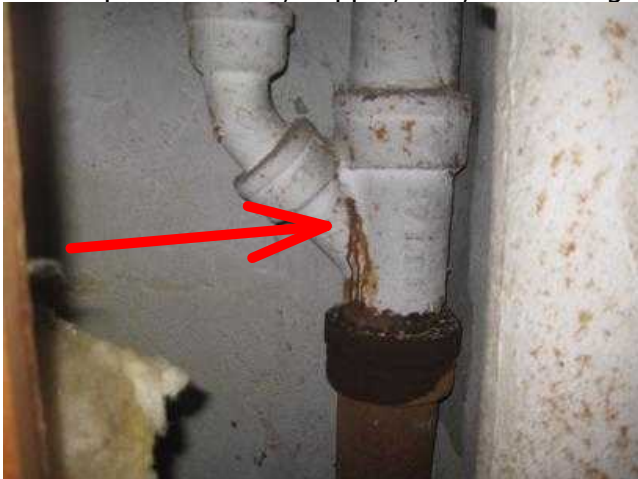
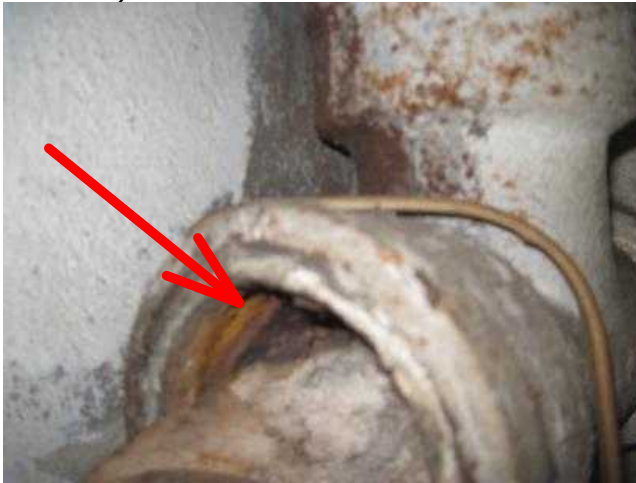
Water Lines: Copper
Drain Pipes: Cast iron, Copper, PVC, ABS Pitting cast iron drain piping

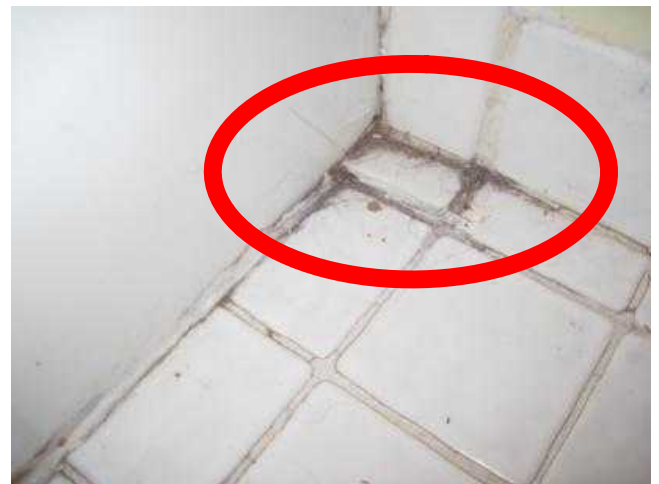
Marginal Floor: Tile Floor shows evidence of previous water penetration/stains

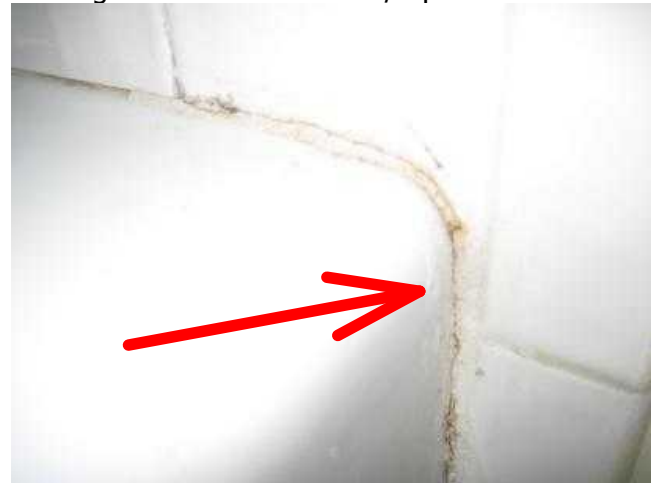
- Acceptable Doors: Solid wood
- Acceptable Windows: Wood double hung
- Acceptable Electrical: 110 VAC outlets and lighting circuits
- Acceptable Counter/Cabinet: Composite and wood
- Acceptable Sink/Basin: One piece sink/counter top
- Marginal Faucets/Traps: Delta fixtures with a PVC trap Slow draining noted-further review/repair
- Acceptable Tub/Surround: Porcelain tub and ceramic tile surround Replace caulking

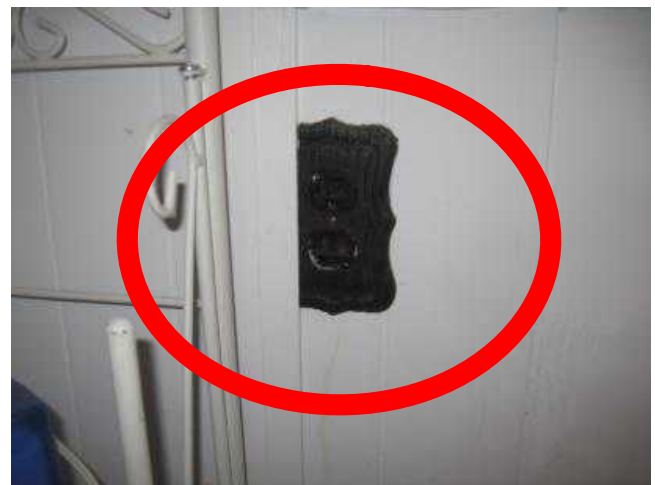
- Defective Electrical: 110 VAC outlets and lighting circuits Non-GFCI circuit -recommend GFCI circuit be installed
- Acceptable Counter/Cabinet: Composite and wood
- Acceptable Sink/Basin: One piece sink/counter top

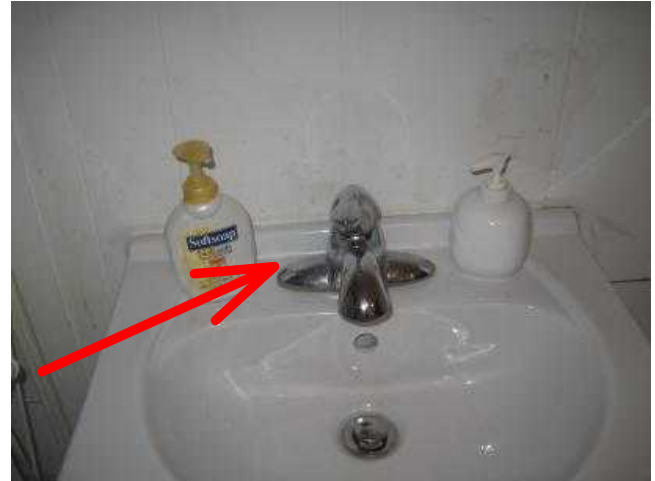
Marginal Faucets/Traps: Delta fixtures with a metal trap
 Fixture loose.

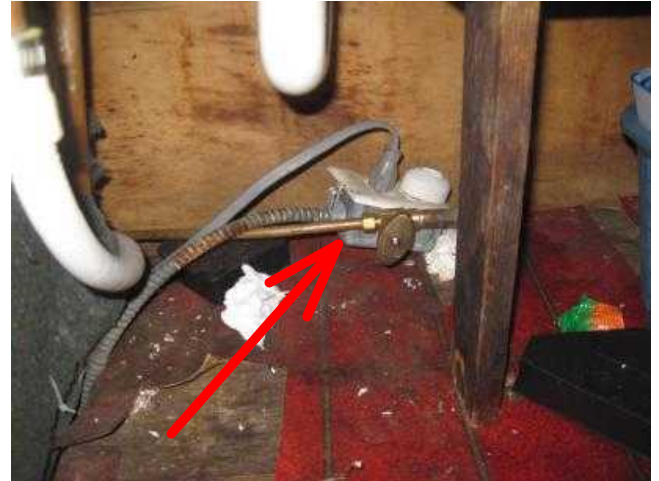
Defective Electrical: 110 VAC outlets and lighting circuits ,
Attach loose outlet.

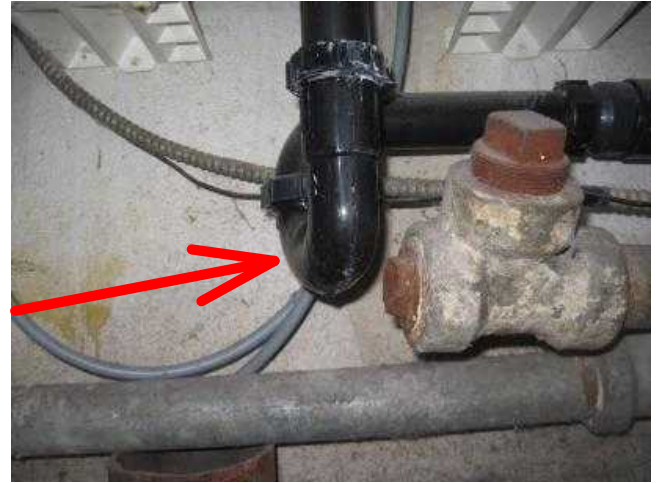
Defective Laundry Tub Drain: ABS The trap is leaking
