Home Inspection Report

123 Forth Place
Anytown, USA 12345

Prepared for: Sample

Prepared by: Caveat Emptor Home Inspectors
14 Sterling Place
Glen Rock, New Jersey 07452

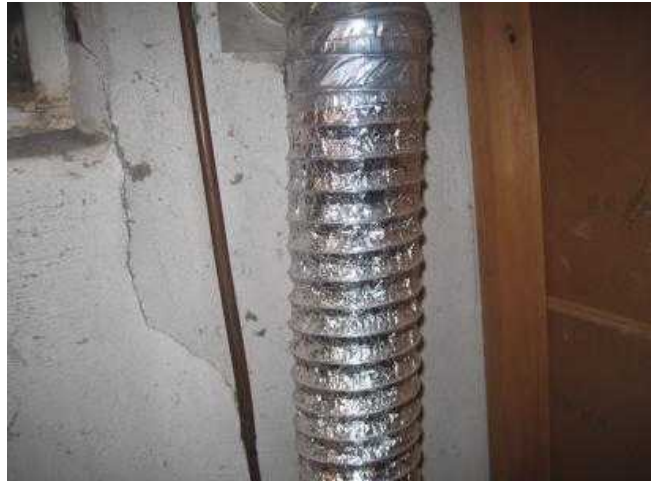
Acceptable Washer Hose Bib: Rotary
Acceptable Washer and Dryer Electrical: 110-120 VAC

Acceptable Dryer Vent: Metal flex
Acceptable Dryer Gas Line: Black pipe
Acceptable Washer Drain: Drains to laundry tub
Not Present Floor Drain:
